## CDI P/N 121-BR50-3.0 Shift Assist Ballast

# Installation and Troubleshooting Guide

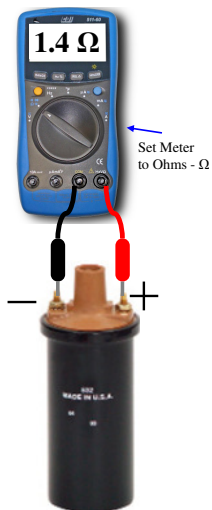
Step 1-  
Disconnect all wires  
from the coil and  
measure its resistance.

Step 2-  
Measure circuit  
resistance between  
Gray and Violet wire

1. Verify correct Ignition circuit resistance. (See Page 2)
  - A) Measure resistance of the coil (Step 1). Normal coil resistance should be 1.5Ω, if less resistance is found a higher resistance ballast resistor may be needed.

- B) Reassemble all wiring, then, disconnect the 2 pin connector containing Violet and Gray (Gray/Black) wires. Measure the resistance between Violet and Gray (Gray/Black) wire on the engine side (Step 2). Measurement should be 3Ω.

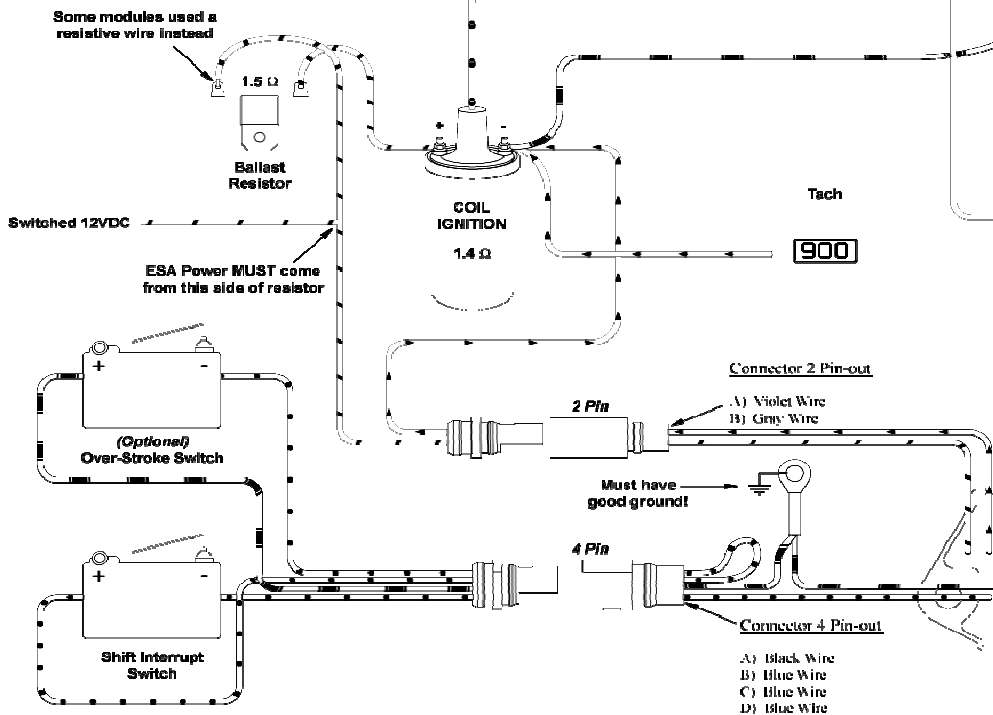
Spark Plug  
Black  
Gray  
Blue  
Violet  
E-point Module

NOTE: The 123-9898-P may not work with Pertronix style E-Points modules if the ballast resistor is omitted or a Hi-current aftermarket coil is used.

- B) **Gray (Gray/Black)** - Negative side of ignition coil to the points. Also for the ESA to monitor the engine RPM and cause the engine to stumble when shifting and provide a Tachometer signal pulse to the dash mounted RPM gauge.
