Installation and Troubleshooting Guide

CDI P/N 123-7567 Electronic Shift Assist 6 Cyl

Replaces P/N's: 763786, 986999, 987403, 987567, and 987875
Use with Prestolite BID Distributor (GM 4.3 Liter V6).

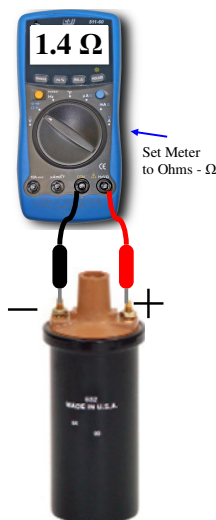
Step 1-
Disconnect all wires
from the coil and
measure it's resistance.

Step 2-
Measure circuit
resistance between
Gray and Violet wire

Ballast Resistor Required
3 Ohms – Step 2 reading =
(See Table for Selection)

3. Verify correct Ignition circuit resistance. (See Page 2)
 - A) Measure resistance of the coil (Step A). Normal coil resistance should be 1.5Ω, if less resistance is found, a higher Ohms ballast resistor may be needed.
